# SAFETY ALERT

NOVEMBER 21, 2016 Page 1 of 2

### FLAGGER POLICY CHANGE

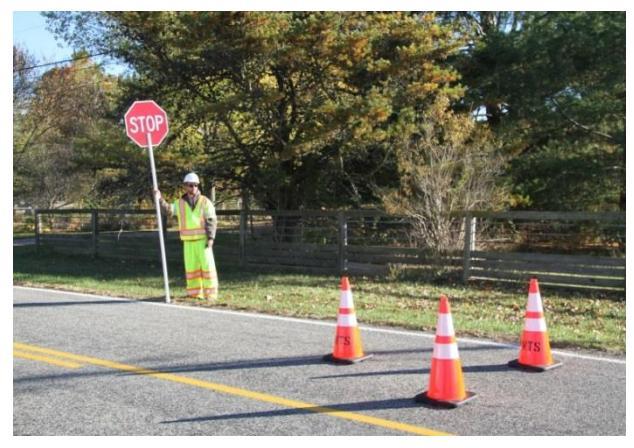
An example of new Class 3 reflective wear requirement for flaggers and placement of three cones 15 feet in front of the flagger position.

- 1. Presently flaggers are only required to wear reflective vests (along with their other PPE). Under the revised policy, the upper portion of the reflective ensemble will be a sleeved shirt with reflective striping on the chest, front, back and sleeves. See image below.
- 2. The second new requirement involves the wearing of high-vis (E-type) trousers or high-vis leggings.

The second policy change involves the placement of additional traffic cones in front of flagging position. Our new policy requires a minimum of three cones be placed in a triangle like formation approximately 15 feet in front of the flagger position. *Note: the flagger should be stationed downstream at least 40 feet beyond the last cone of the taper.*
